**NEW HAMPSHIRE HISTORIC PROPERTY DOCUMENTATION  
SHORT FORMAT**

**CHURCH STREET PUMP HOUSE**

NH State No. 718

**LOCATION:** 50 Church Street, Hampton, Rockingham County, New Hampshire.  
USGS Hampton NH Quadrangle. UTM Coordinates: 19.352086.4753063

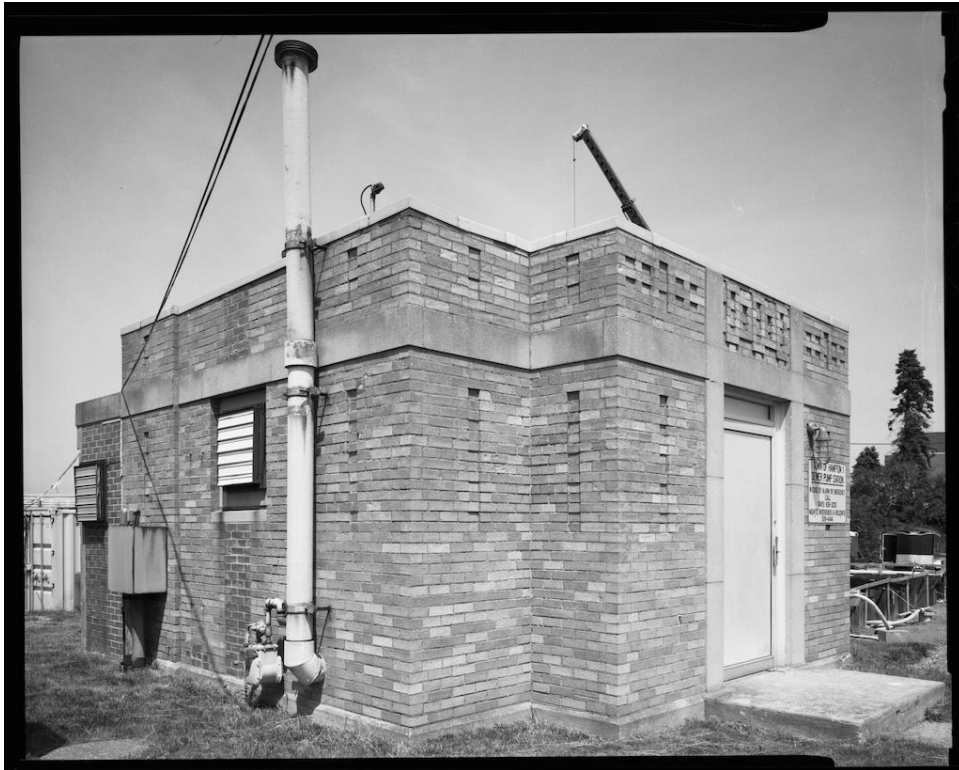
NH-718-1: Front (south) and west side elevations. Looking northeast.

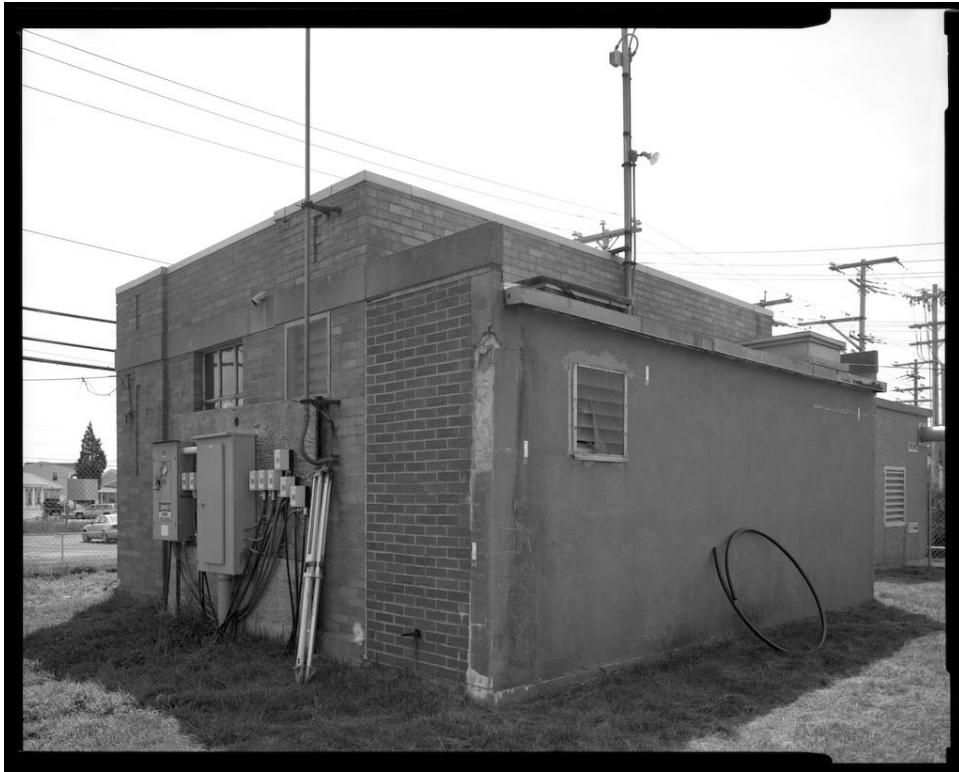
NH-718-2: East elevation and rear addition (1968). Looking southwest.

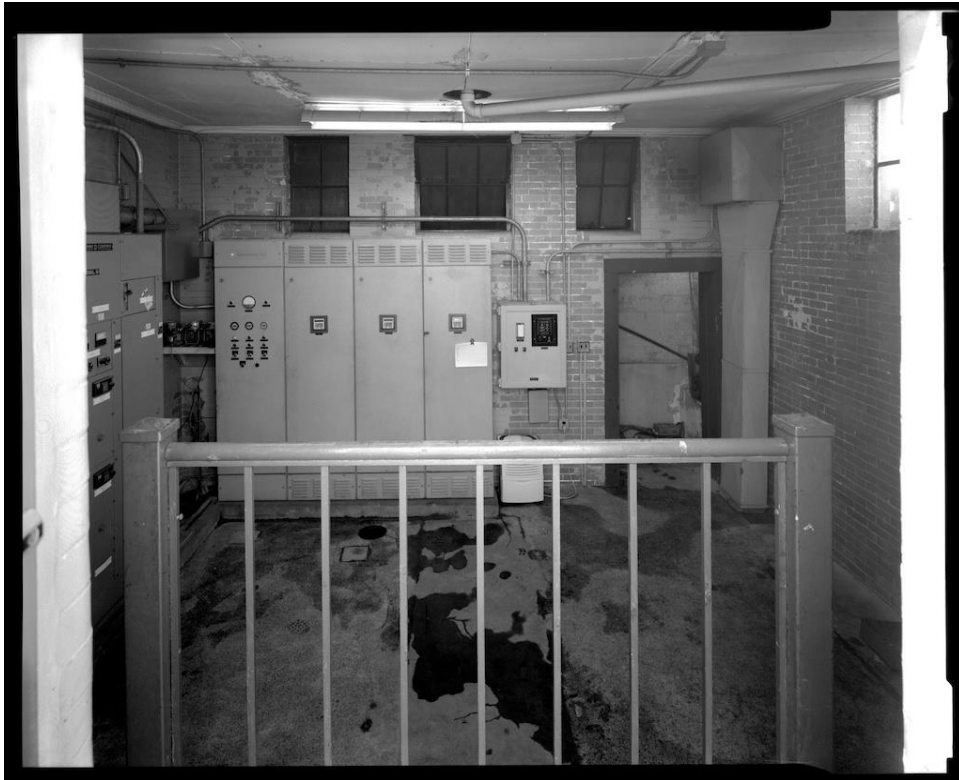
NH-718-3: Interior, ground level control room, view through open front door, showing original stair railing, foreground; original steel tilt-sash windows on rear wall now enclosed in stairwell addition; modern electrical control panels. Looking north.

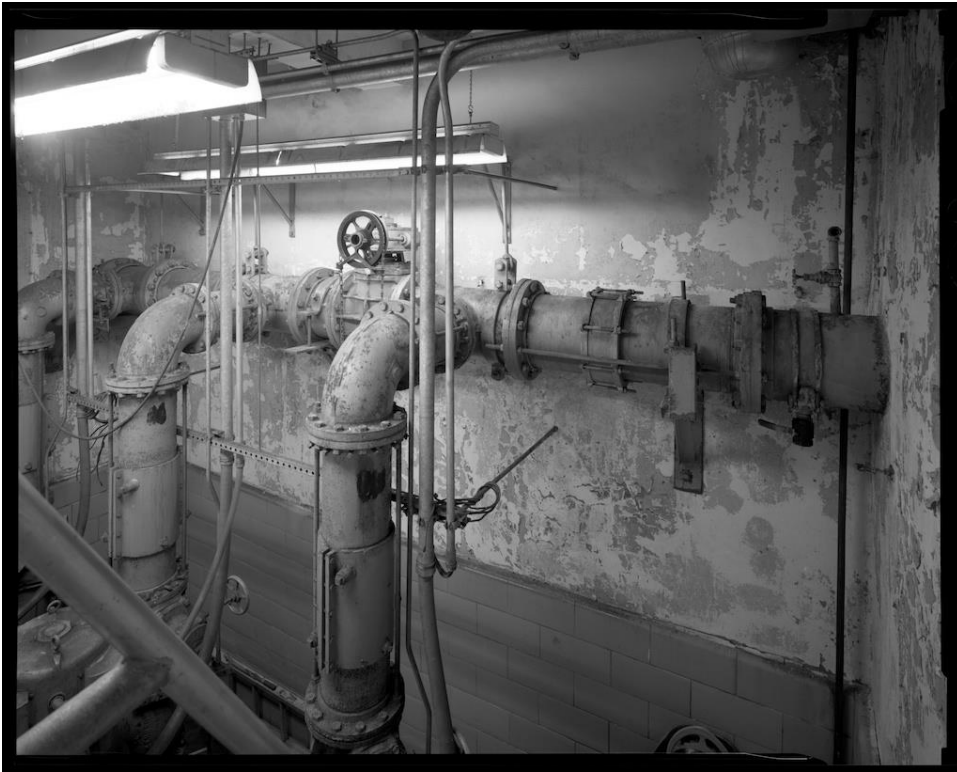
NH-718-4: Interior, lower level, showing original concrete walls with ceramic tiling, some original piping components. Looking southeast.
